TRI-SERVICE CONFERENCE ON CORROSION

Shipboard Exposure Testing of Aircraft Materials

Edwin S. Tankins*, J. Kozol & E. Lee

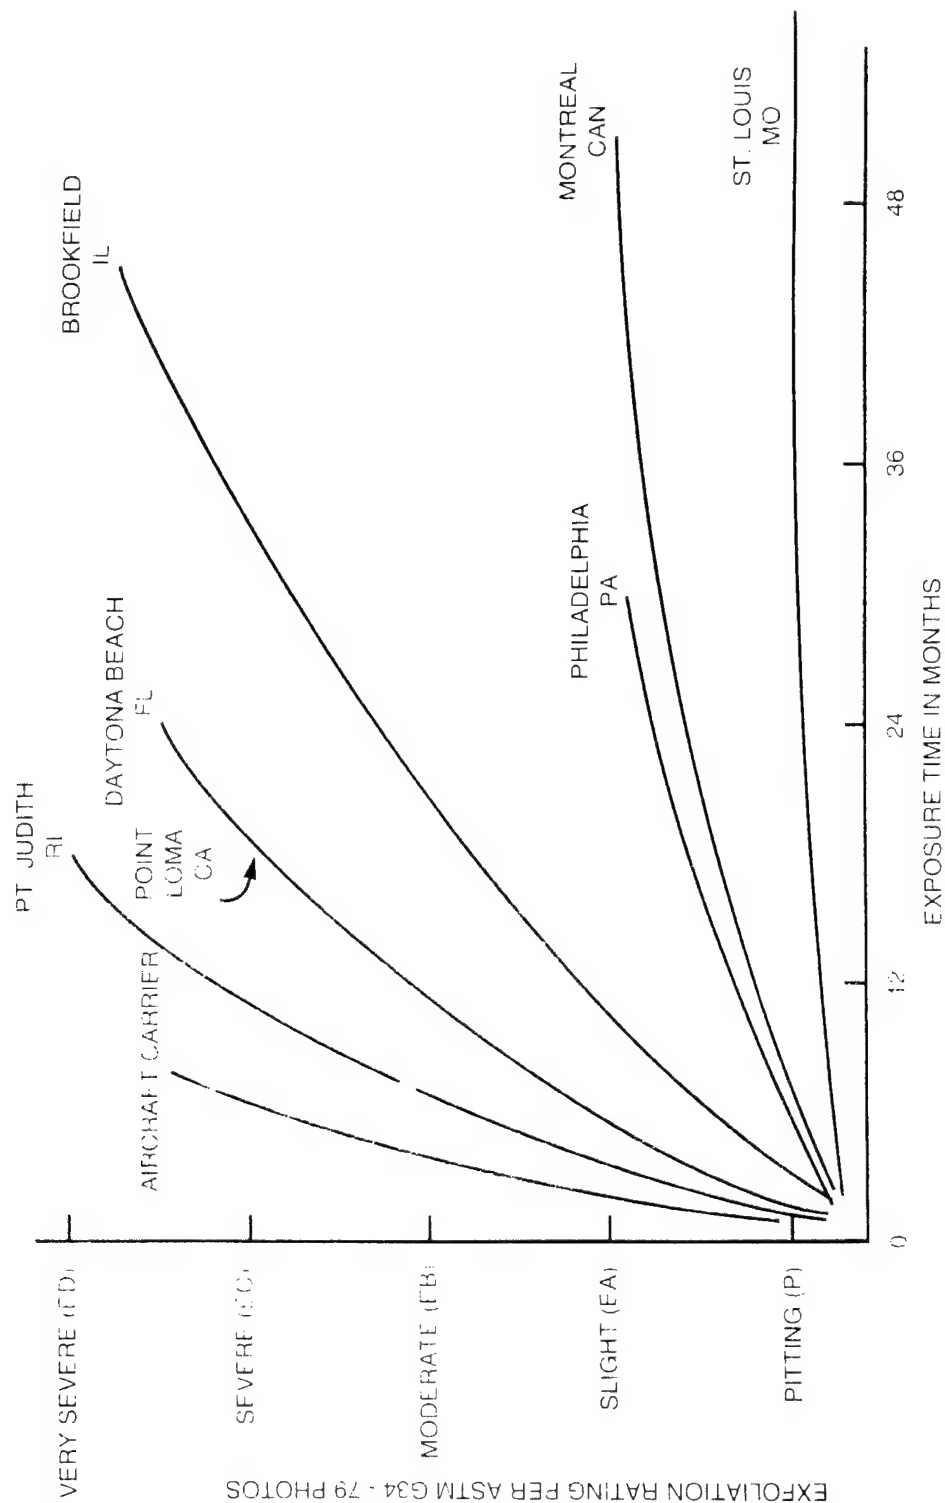
The study of various alloys included exposure aboard aircraft carriers as part of a series of exposures for the last ten years. Figure 1 summarizes the results of previous testing and shows that the carrier environment is more severe than seacoast or industrial environments (2). However, large differences exist between theaters of operations. Environmentally, the Indian Ocean deployment during the monsoon season is far more severe than the Atlantic or Mediterranean Sea deployment from which previous comparisons were made. Susceptible aluminum exposed aboard nuclear powered carriers (no stack gases) exhibited behavior similar to that aboard conventionally powered carriers (stack gases with jet engine

There has been considerable testing performed in various locations. There are pronounced differences in locations and environments. For instance, the Indian Ocean during the monsoon appears to be more severe than the Atlantic or Pacific. The work of Ketchum, et al (2) showed a comparison of the various environments. Figure 1 was first shown in their work (2) and is an excellent comparison.

Fig. 1 - Comparative corrosivity of natural environments

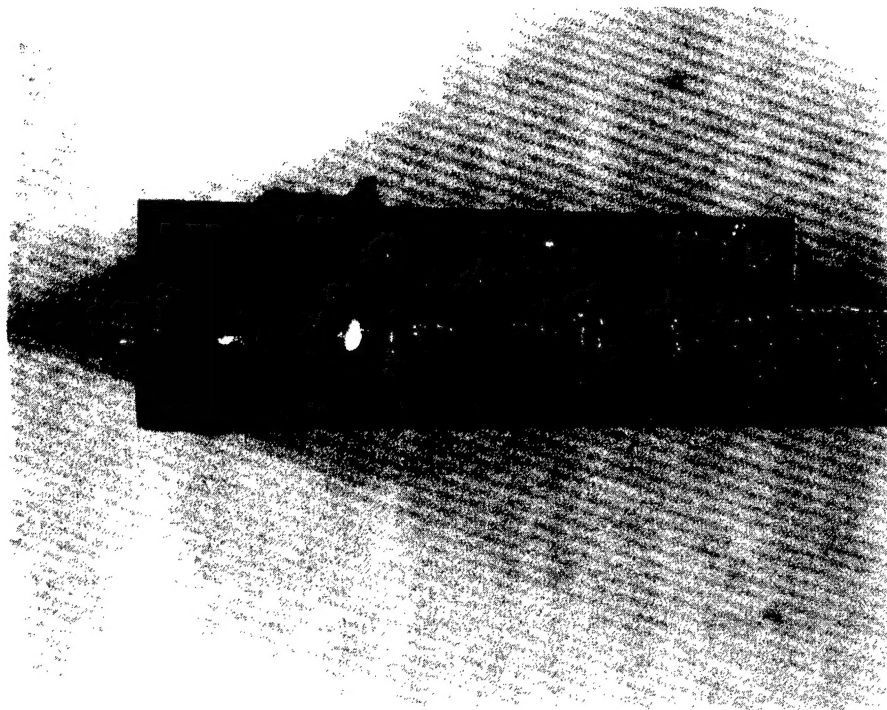
Fig. 5 - Side view of 7075 - 76 alloy showing extensive Ex_f liation.

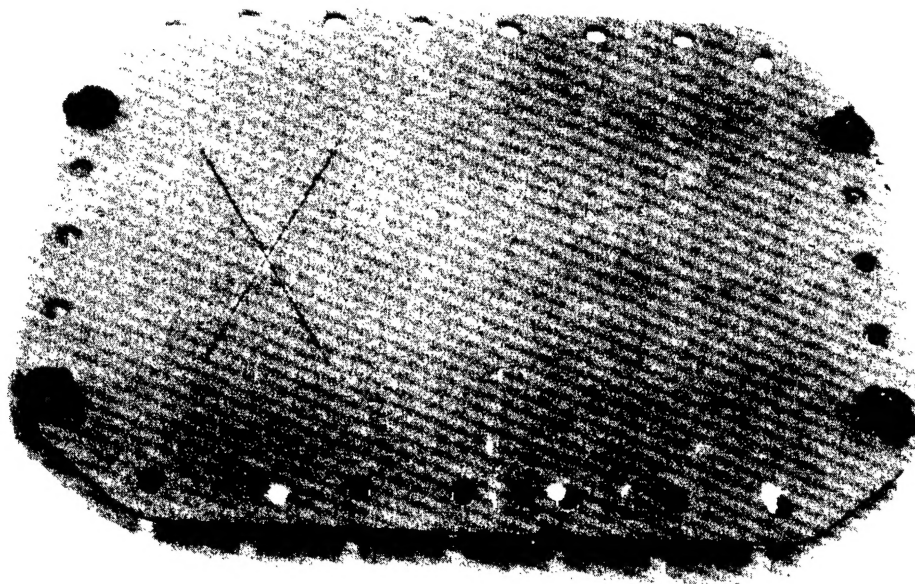
After 2 years at Key West, Florida, a small amount of incipient exfoliation appeared on the T/2 plane of the 7075-T6. Figure 6a compares access panels of 7075T6 and 209078 Al-Li alloy for the F/A-18. Figure 6b shows what looks like a slight blistering at the scribe mark. By comparison Fig 6b looks clean at the scribe marks. The behavior is basically comparable.

Fig. 6 - Access Panel from F/A - 18 with Scribe Marks.

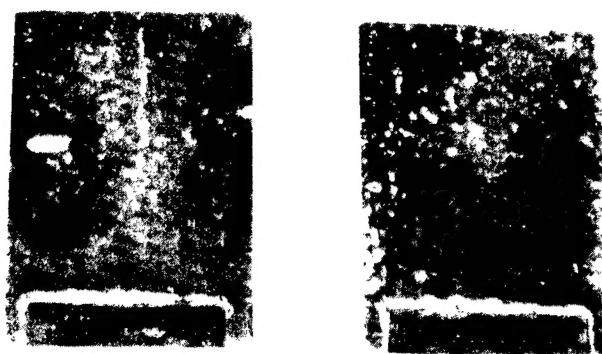
The laboratory tests indicate at 96 hours the 0.3 mil and 0.5 mil Cd plated plate shows corrosion, and the 1 mil shows discoloration. These results are shown in Figure 7. This is similar to what is often seen on carrier exposure.

*Fig. 7- Cadmium Plated Steel Panels after 120 hrs
of laboratory SO₂ Salt Spray.*
